County of Bruce

Class EA for the Durham Street Bridge

Community of Walkerton

Public Information Meeting

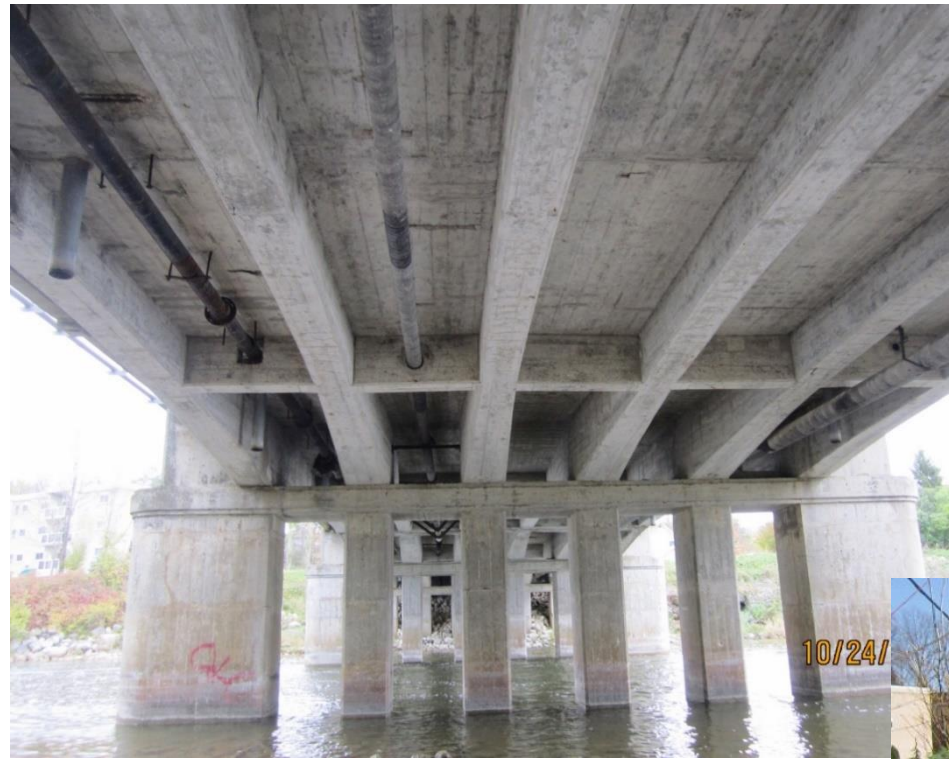
Bridge Details

- Five span rigid frame T-Beam Girder Bridge with a drop-in centre span with half joints and cantilevered end spans.
- Constructed Circa 1937

The bridge is a rare example of what was once a common concrete rigid frame T-beam bridge design with embossed stanchions/ pillars, railings, and cantilevered end spans associated with late 1930's provincial bridge design

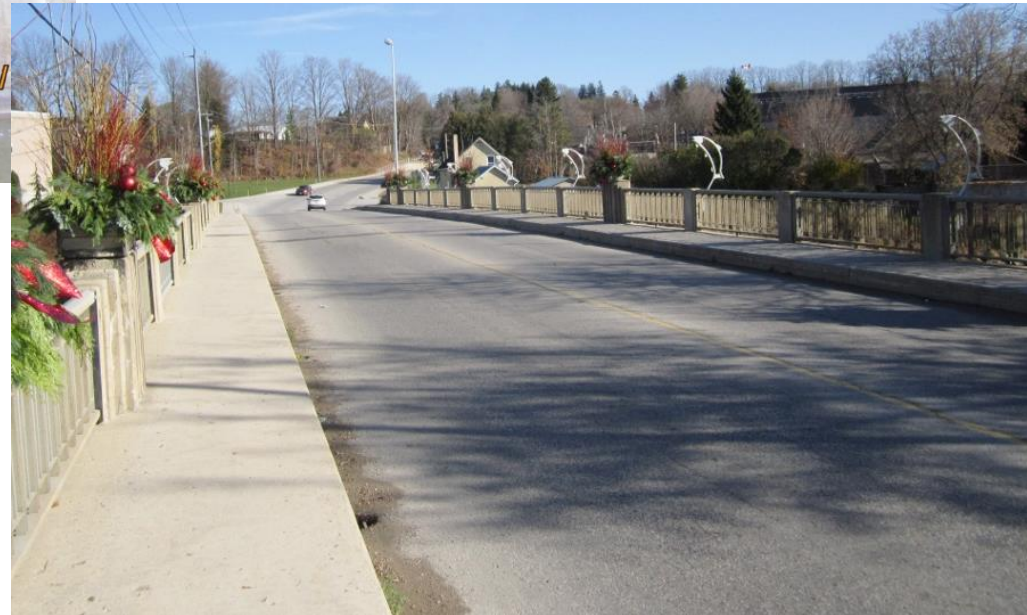
Deficiencies

- Concrete Deterioration
- Safety concerns associated with the drop in centre span

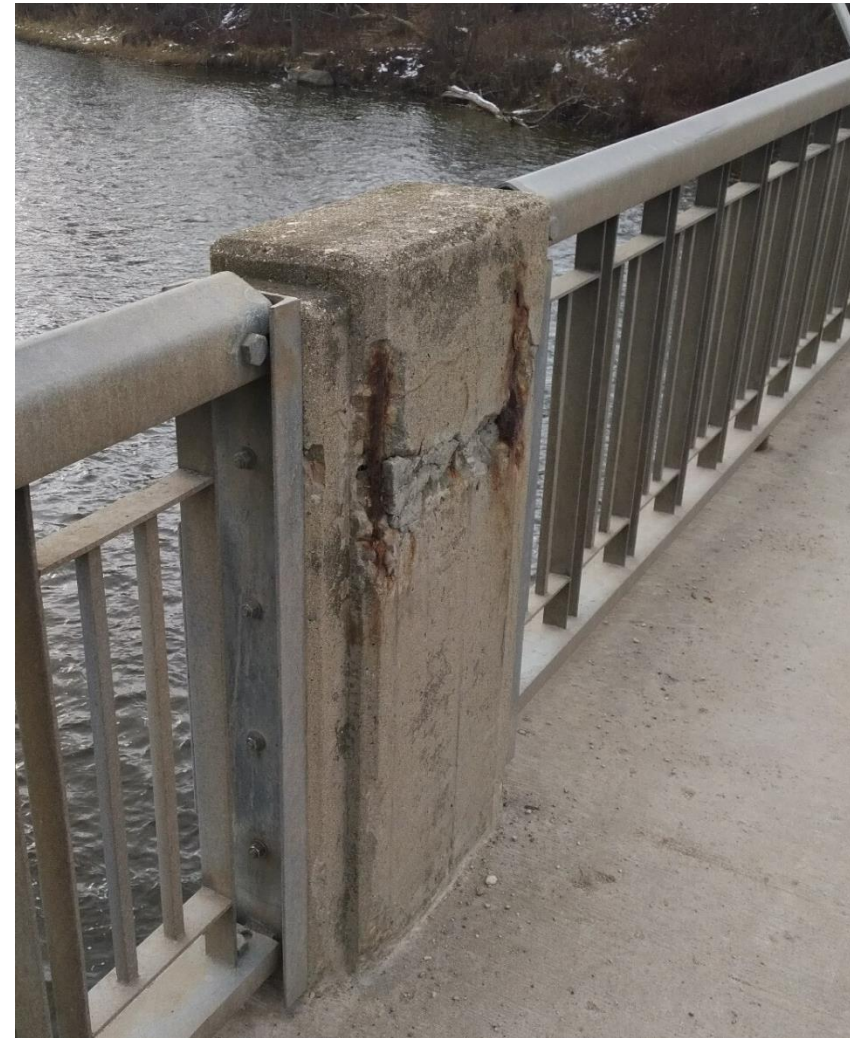
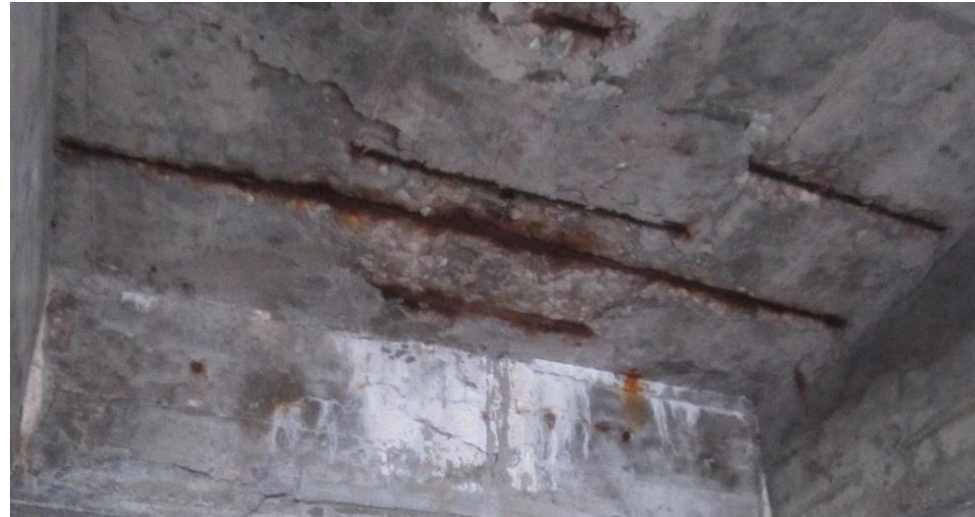
Concrete deterioration

Durham Street Bridge - Deficiencies

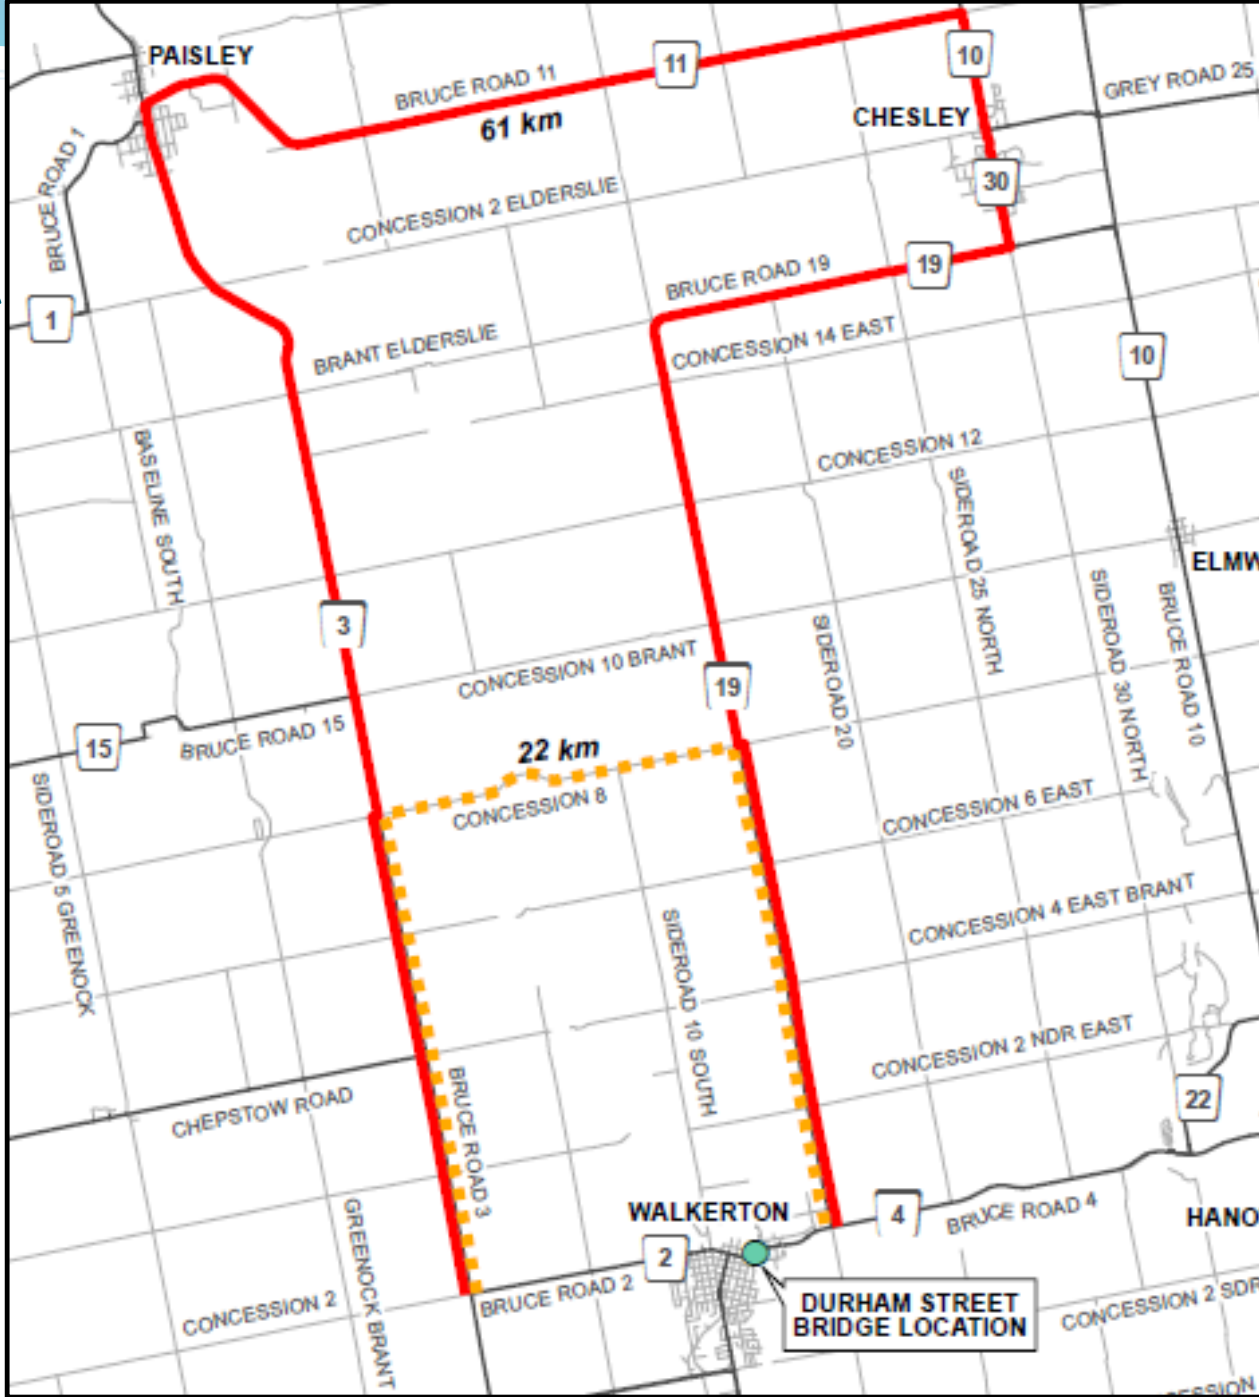
Detour Option 1A – County Roads North

- **Alternative 1A & 1B** – Detour using County Roads
 - County Road detour north and south of Walkerton
- **Alternative 2** – Detour using local roads
 - Detour north of Walkerton using Bruce Road 19 and local roads and provide a transit stop for pedestrians
- **Alternative 3** – Temporary Vehicle Bridge
 - Install a temporary vehicle bridge upstream of the bridge adjacent to Orange Street, connecting to McNab Street
- **Alternative 4** – Temporary Pedestrian Bridge
 - A pedestrian bridge installed upstream of the bridge adjacent to Orange Street, connecting to the trail network

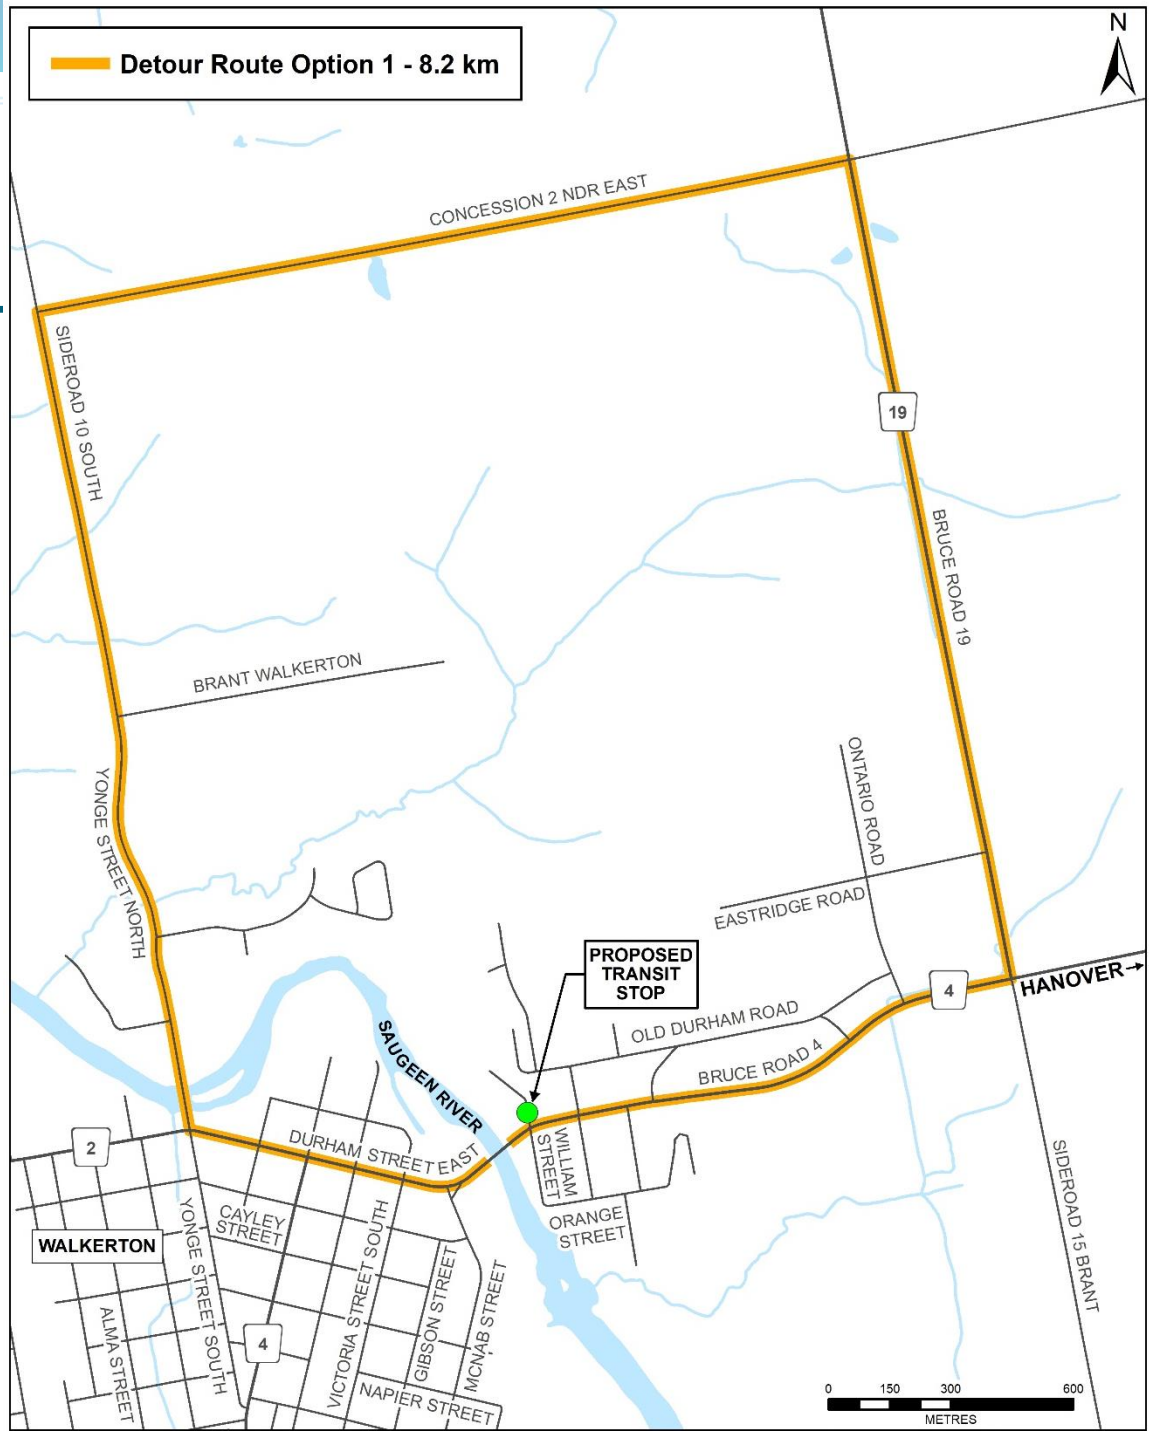
Detour Option 2 - Local Roads

- Local traffic to use local detour to the north via Bruce Road 19, Concession 2 and Yonge Street
- Transit stop to be created on the north side of the river to convey pedestrians into Walkerton
- Truck traffic encouraged to use truck detour routes
- Concession 2 and Yonge Street to be upgraded with additional lift of asphalt to improve road base
- Improvements planned for intersections of 19/Conc. 2, Yonge/Conc. 2 to improve turning radius
- Improvements at Yonge/Durham Street to improve turning radius and provide temporary signals

● **Local Detour – Option 2**

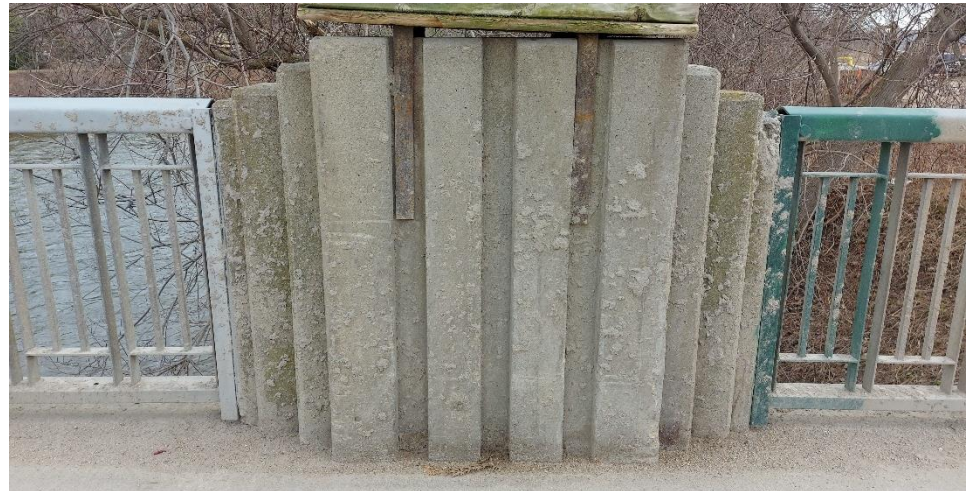
Preliminary Design

- Three spans/2 in-water piers
- 2 Sidewalks 1.8m (6') wide
- Maintain integrity of dyke
- Sympathetic design of posts

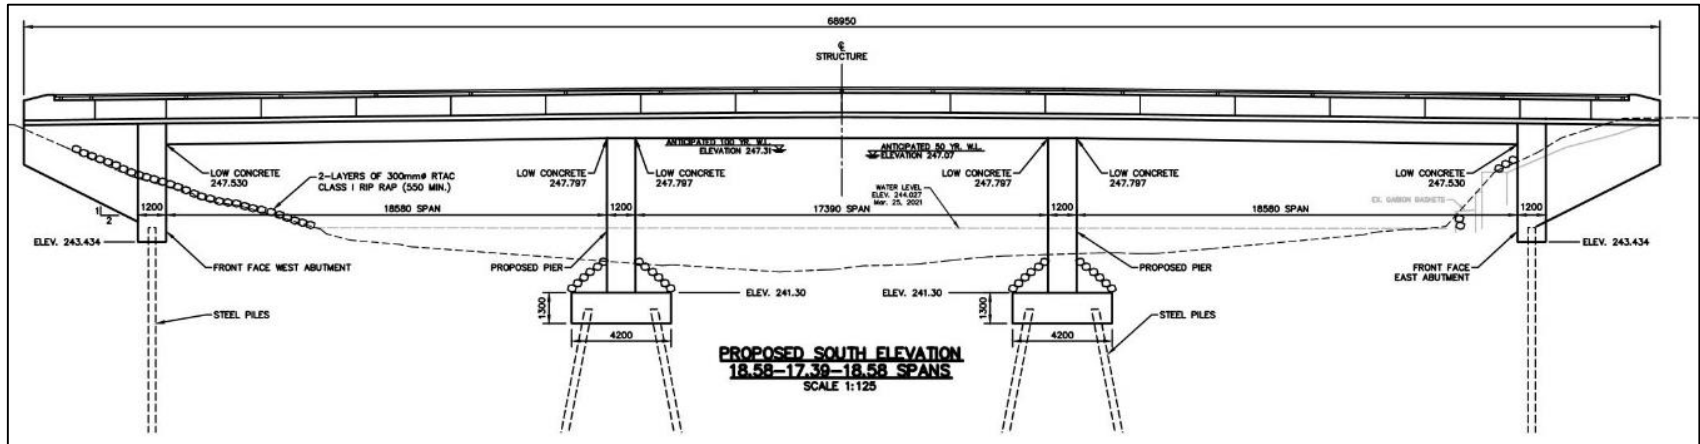
Option #1 – Piers in same location

- Two hydraulic design options considered for the proposed bridge.
- Existing bridge includes 4 piers and arch beam design.
- Proposed bridge options include 2 piers and varying span alternatives
- Both options improve the efficiency of structure for flow and ice movement.
- Option 1 has the middle piers in the same location as the existing structure
- Option 2 has piers offset to create a wider middle span

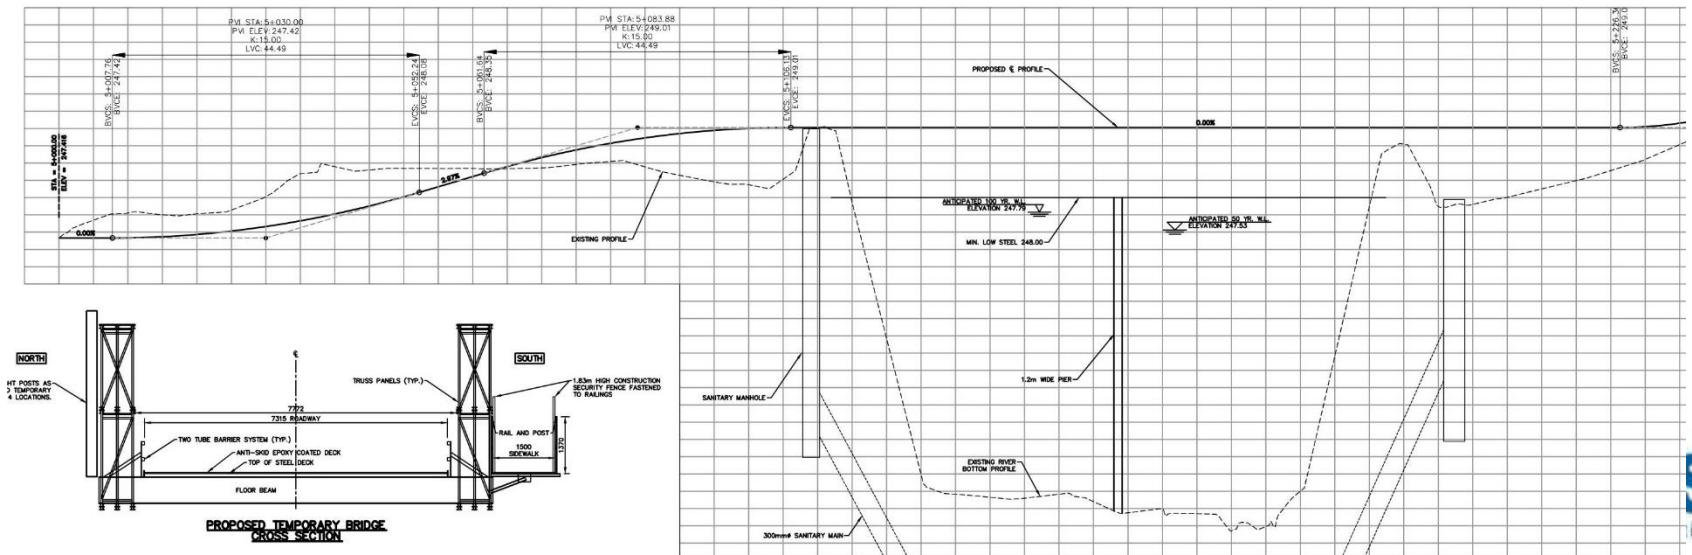
- **Temporary Detour Bridge Option**

- Designed to 100 year return event, with negligible impacts on flooding up to 100 year.
- Construction contingency plans to include stockpiling of sandbags or steel sheet piling to fill any breach in the dyke due to construction
- Full restoration of dyke proposed post construction.
